**RE: Frances Carlton Condominiums - Existing Building Assessment  
Phase One Milestone Inspection  
1221 North Palm Avenue, Sarasota, FL 34236  
KEG File# 21RS-0850**

RE: Transmittal of Concrete Section Information  
Foundation Investigation  
Frances Carlton Condominiums  
1221 N. Palm Avenue  
Sarasota, Florida  
Our File: DES 228887

**TRANSMITTAL OF CONCRETE CORE INFORMATION  
FOUNDATION INVESTIGATION**

**FRANCES CARLTON CONDOMINIUMS  
1221 N. PALM AVENUE  
SARASOTA, FLORIDA**

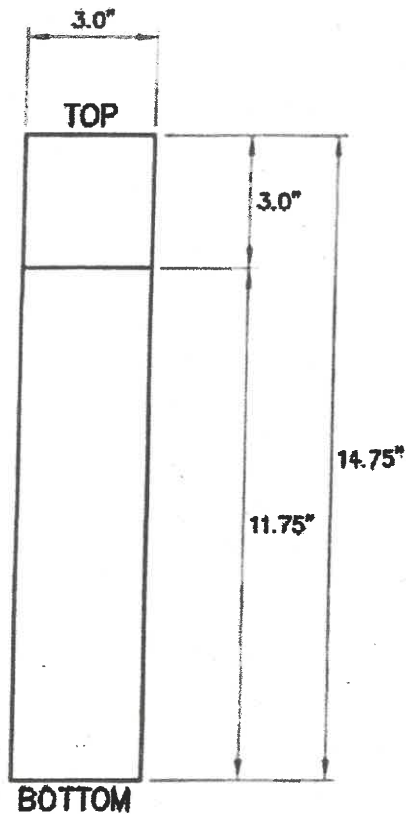
| SHEET TITLE | PREPARED BY |
|---|---|
| <b>CONCRETE CORE C-1 DETAIL</b> | <br><b>DRIGGERS ENGINEERING SERVICES, INCORPORATED</b> |

One core sample, C-1, was taken at a distance of one foot from the interior basement wall and the second core sample, C-2, taken a distance of three feet from the same interior basement wall. At core location C-1, two layers of concrete were found, the top layer of 3" thickness with a bottom layer of 11 ¾" thickness. At core location C-2, one layer of concrete was found of 8 ¼" thickness.

CONCRETE CORE C-1 PERFORMED 0.5' AWAY FROM BASEMENT WALL.

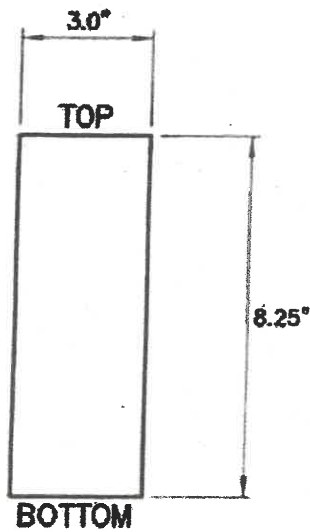
| SHEET TITLE | PREPARED BY |
|---|---|
| CONCRETE CORE C-2 DETAIL | <br>DRIGGERS ENGINEERING<br>SERVICES, INCORPORATED |

CONCRETE CORE C-2 PERFORMED 3.0' AWAY FROM BASEMENT WALL.
